**LITTLE TUNNEL  
STABILITY ASSESSMENT  
CUMBERLAND GAP, TENNESSEE**

**Vaughn & Melton Engineers  
P.O. Box 1425  
Middlesboro, Kentucky 40965**

**April 1995**

**953-3720**

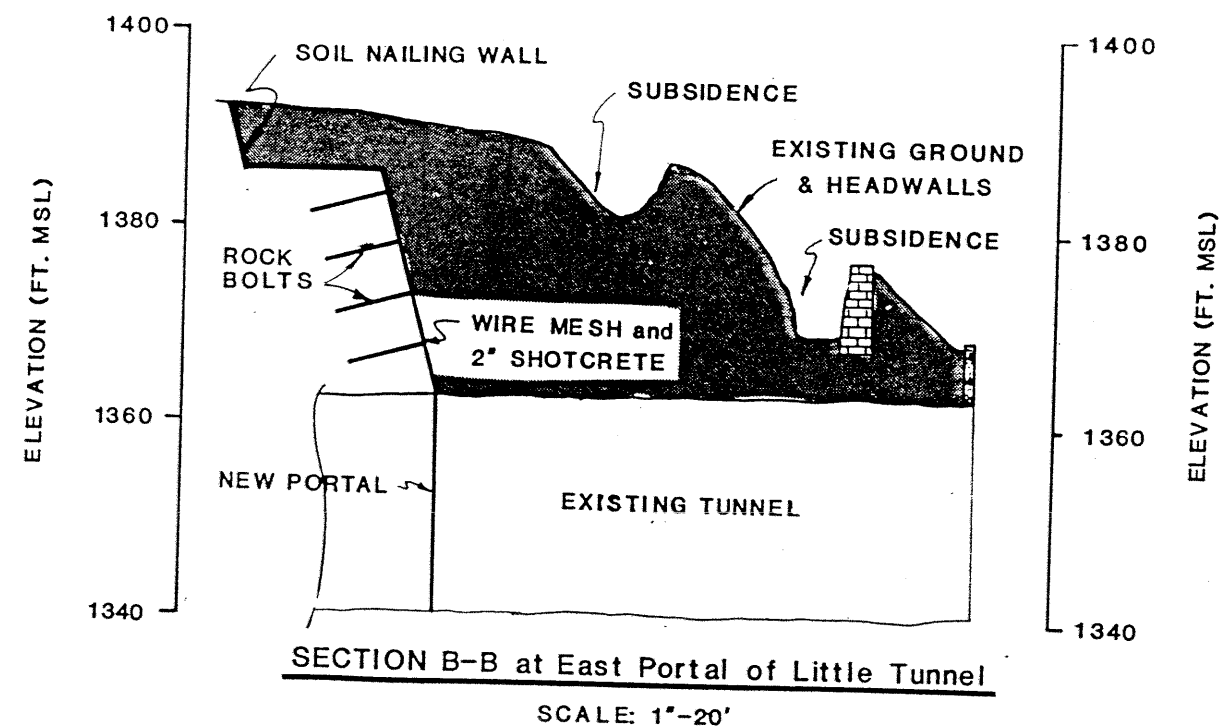
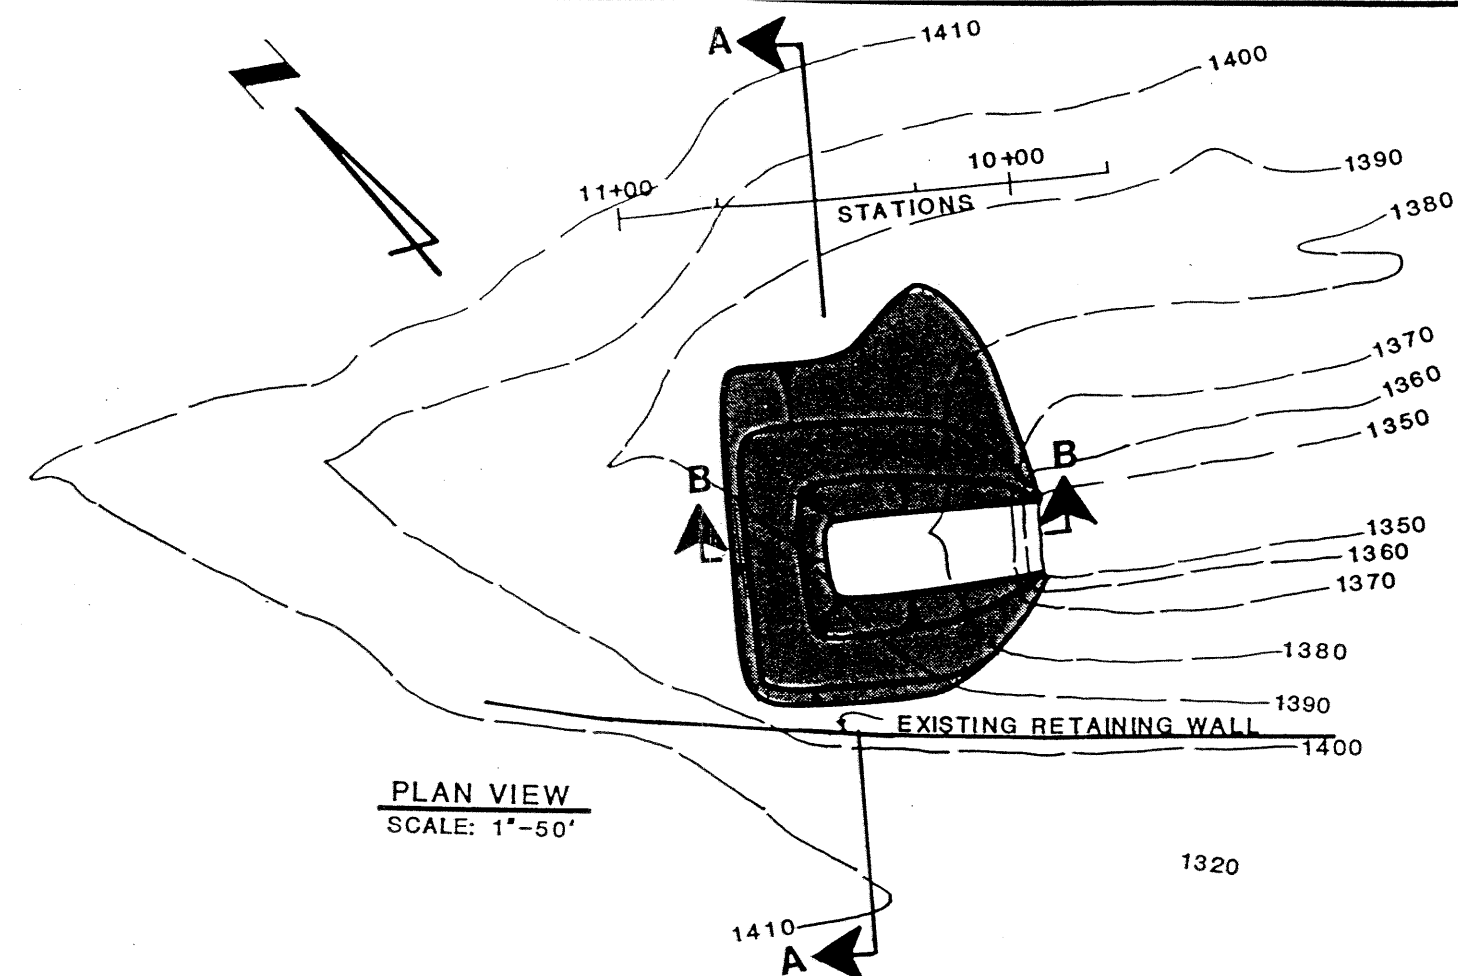
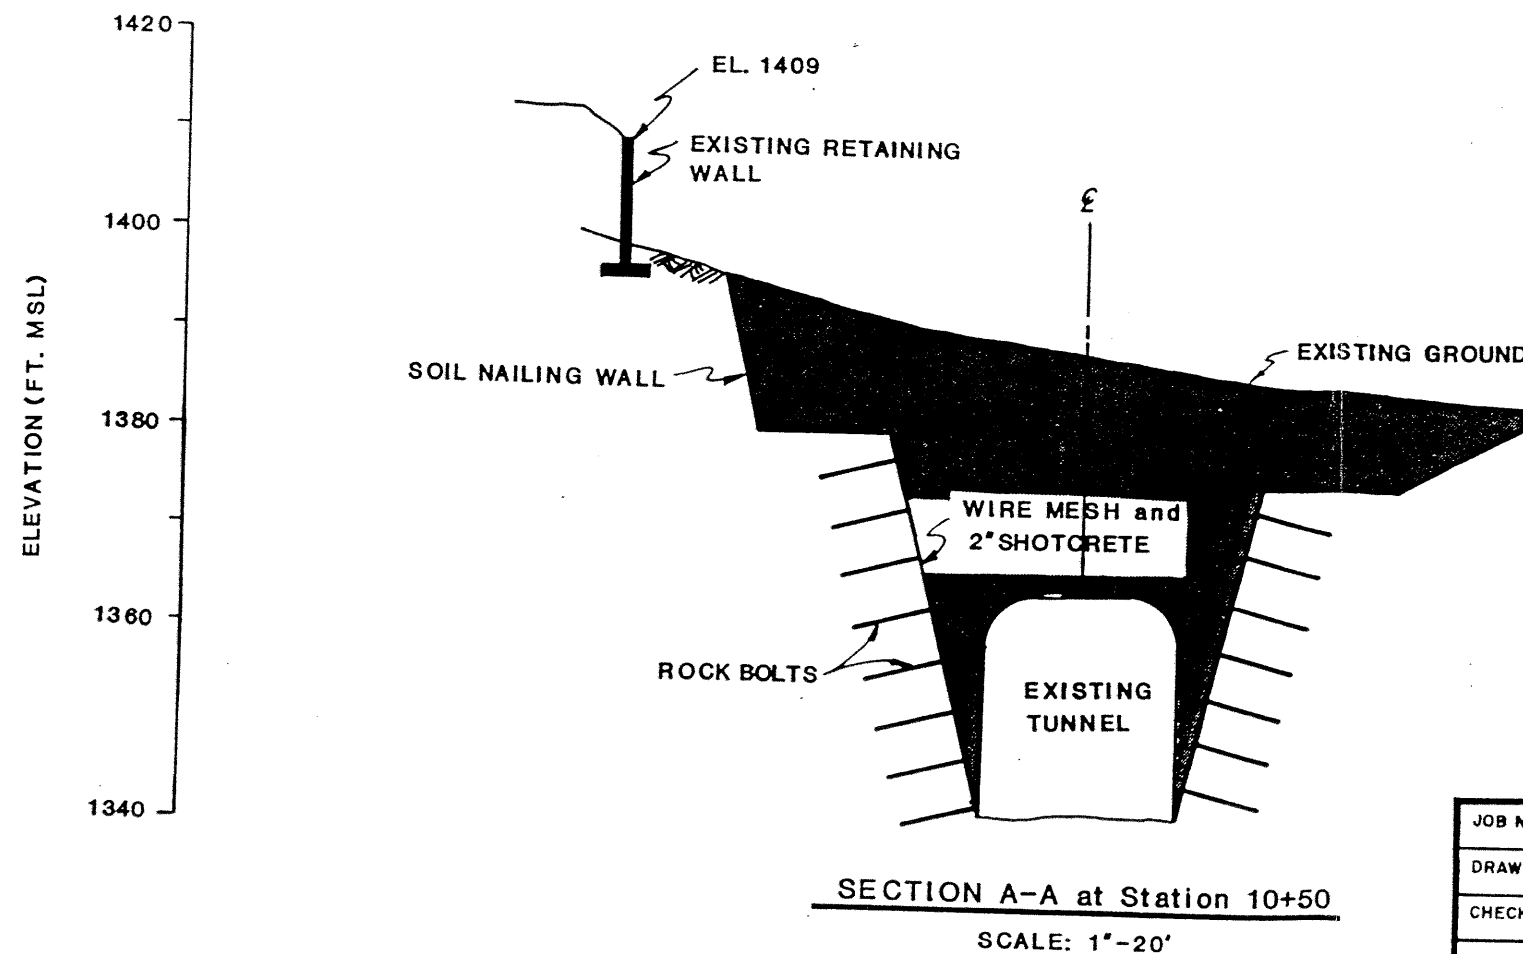
JOB NO. 853-3256	SCALE AS SHOWN	TYPICAL REINFORCED CONCRETE SUPPORT SYSTEM	
DRAWN T.S.R.	DATE 5/20/86		
CHECKED	DWG. NO.		
Golder Associates		LEE WAN AND ASSOCIATES	FIGURE 9

At the east portal there are major stability problems. We observed two large subsidence pits centered at about 16 ft. and 36 ft. behind the headwall and another small subsidence immediately behind the headwall (see Figure 9). The subsidence pit at 36 ft. behind the headwall corresponds to the bulge in the timber supports within the tunnel from Bay 8 through 12.

On the south side, the excavation encroaches on the existing retaining wall along U.S. 25E. The cross section in Figure 9 shows the constraint presented by the existing wall. The temporary excavation required to build a conven-

An additional option for stabilizing the East Portal, is the construction of a reinforced concrete liner immediately below the existing timber set system. The conceptual design for this solution is shown in Figure 9.

The reinforced concrete option would be the same in all respects, as already described for the East Portal and as illustrated on Figure 9, except for the probing and filling of crown void spaces. It is considered that in this case, in view of the much greater cover, there will be no need to fill existing voids to prevent ground subsidence.
